RE: 1st Revision to PCB Cleanup and Disposal Notification
Joseph A. DePaolo Middle School, 385 Pleasant Street, Southington, CT

**REVISED PCB SOURCE MATERIAL & BUILDING
MATERIAL SAMPLE LOCATIONS & RESULTS TABLE**

**EXISTING EXTERIOR WALL LAYOUT
& PCB REMOVAL LOCATIONS**

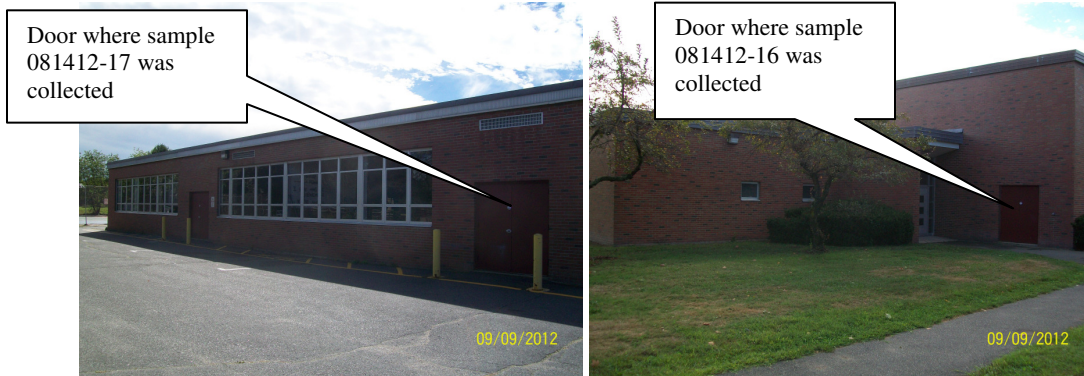
- A. Sample 081412-16 and -17 are indicated to be an exterior red door caulk but are shown as a double door on the drawing. Please confirm sample id and location. **Sample ID and location are correct. Please see photos below, the majority of the red doors are double doors.**
- B. Sample -16 has a PCB concentration of 41 ppm, which is a factor of 10x higher than sample -17. Thus, please confirm if other similar doors are present that have similar caulk but were not sampled for PCBs. **There are a total of ten single and double red doors. All doors look identical and the caulk visually appears to be the same.**

- C. EPA also notes that adjacent building substrates located adjacent to sample -16 were not sampled to confirm the PCB concentration. Please clarify why given the PCB concentration in the caulk. **The caulk for the doors was classified as homogeneous based on the color, age and the fact that no samples were found >50PPM. When the building material sampling was performed, locations were selected from each side of the building and from each type of substrate by the inspectors without looking at specific sample results from the initial survey to avoid a biased sampling approach.**

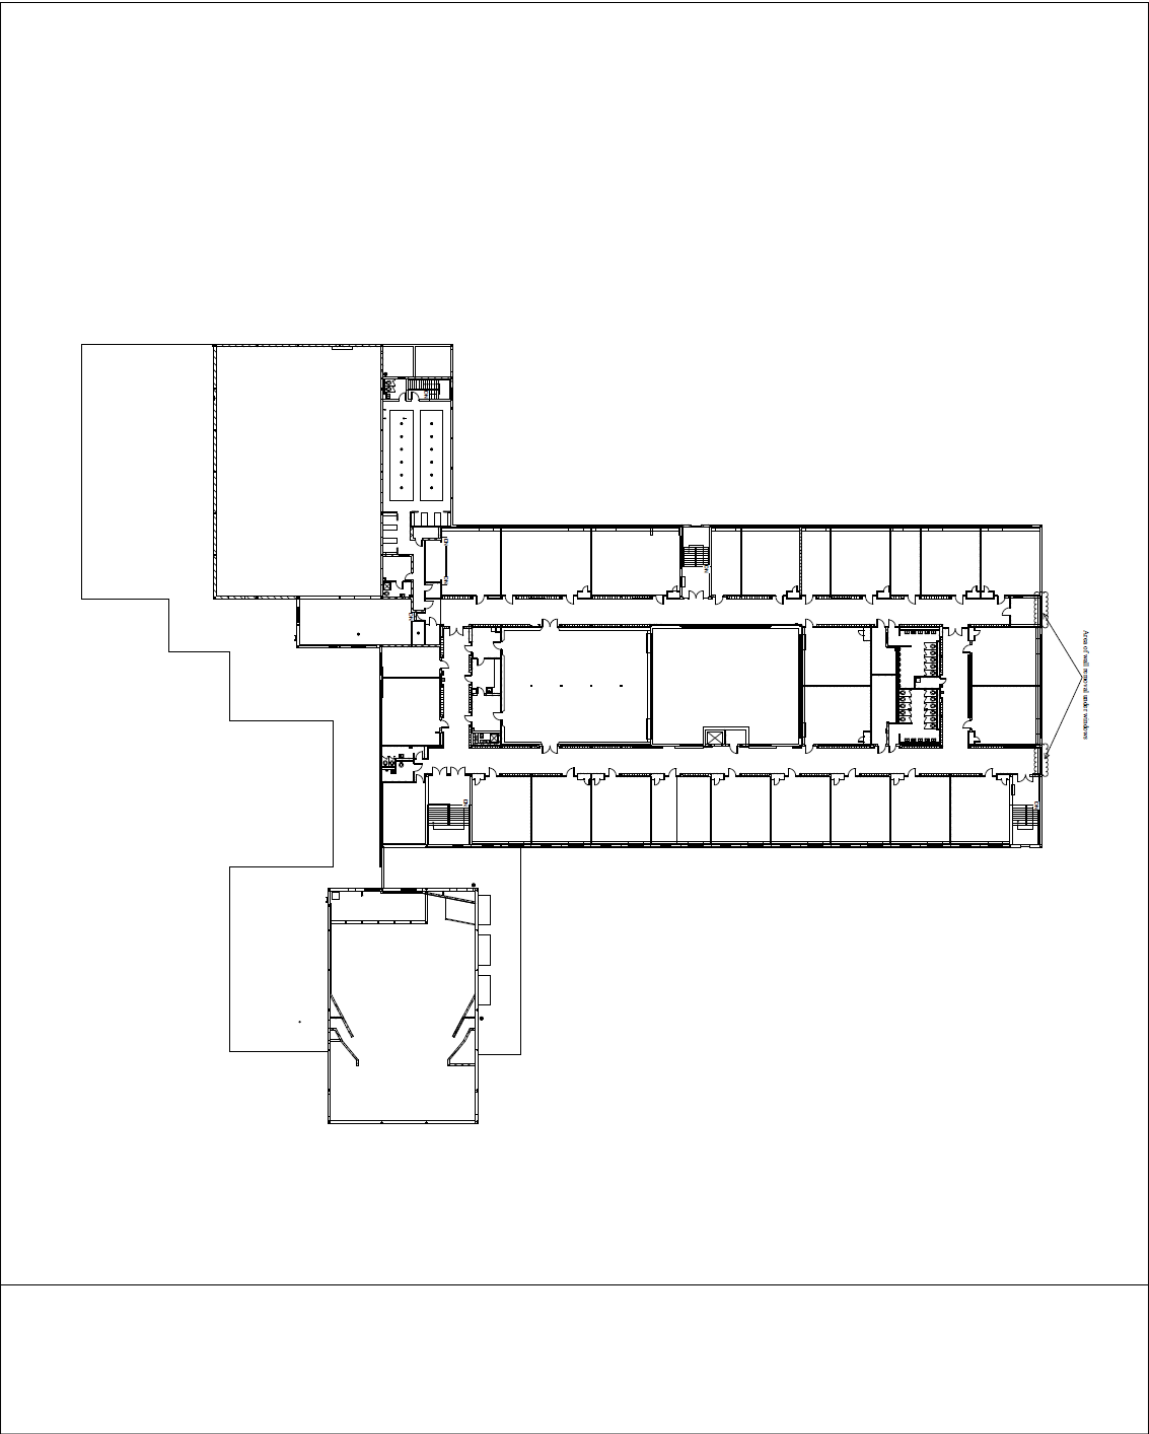
- h. With respect to the vapor barrier/mastic to be removed as part of the expansion, it would be helpful if a figure could be provided which specifically identifies those walls that will be removed (and thus the vapor barrier) as part of this project. Please also clarify the quantity of materials that would be removed (i.e., inner cinderblock wall coated with the vapor barrier/mastic). Given that there is a minimum of 3 to 4 inches between the exterior and interior walls, EPA assumes that there would be limited potential for contamination to the exterior wall from the PCB-containing mastic/vapor barrier, but EPA requests clarification on this point. **Please see the attached drawings in PDF with the location of exterior brick and cinderblock wall removal. The total area of removal is as follows:**

- i. **Approximately 21 square feet of wall removal below the two second floor window on the South end of the building where the halls connect to the new addition.**

- ii. **Approximately 60 square feet of wall removal for new double door entrance.**
- iii. **Approximately 600 square feet of wall removal at the current main entrance to create an open stairwell/entry.**
